## **Report on geophysical logs in the MEL-5 borehole (Lipnice nad Sazavou, Czech Republic)**

Requested by Aquatest a. s. divize karotáž

*Geo-Log Ltd.  
Budapest,  
10. 01. 2006.*

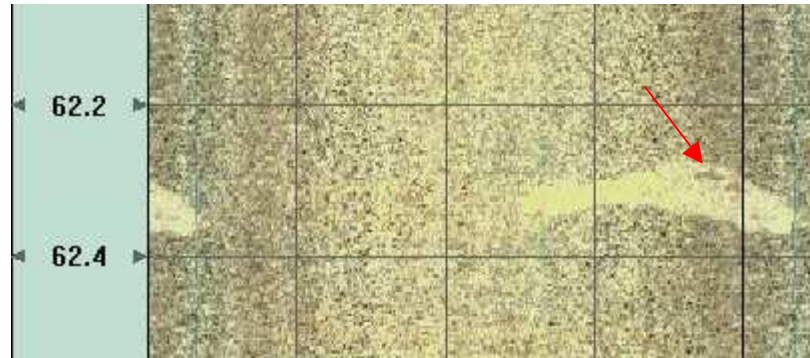
The OBI could be performed along the entire length of the borehole (Annex VI.). The measured azimuth is affected by the steel casing and therefore incorrect from the top to 16.7m, where the bottom of conductor casing was found. The water level is clearly seen at 22.1 m. In general, the recorded optical image confirms the existence of the fractures determined from the ABI log, but in some cases it provides further information as well. For example white features can be observed at depths of 19.8 and 62.4 m, which look as filled veins. In case of the lower one even a small piece of the host rock was also observed in the white mass, which might have broken off from the

side of the fracture (Pic. 1.) The filling material is likely to be some white mineral (or minerals), which, regarding its physical properties, does not differ from the host rock, because the ABI log does not indicate it. It is supposed that it is quartz or feldspar, originated in a later phase of the magma cooling.

Picture 1.: The white feature with the host rock fragments

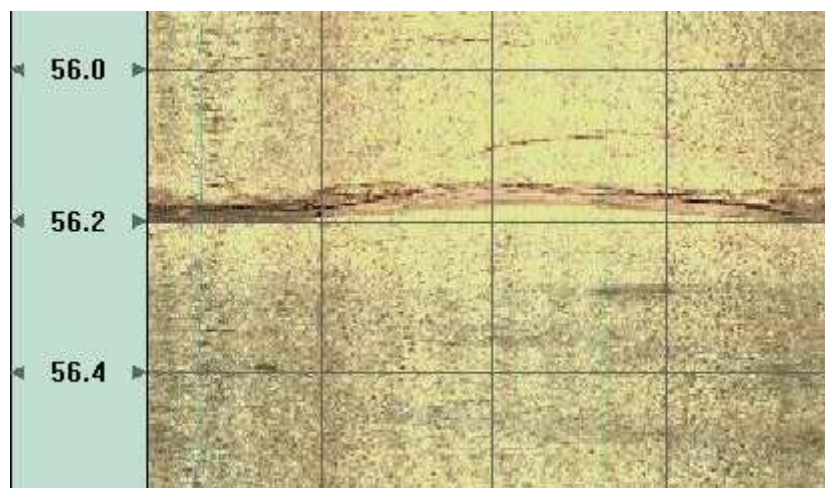
In accordance with the ABI log the OBI log shows well the fractured intervals, which fit well to those determined by Aquatest with injection method. Clearly observable open fractures are found at 35.0 m, 48.2 m, 48.8 m, 56.2 m, and 98.2 m. However at 106.6 m only a minor fracture can be observed. According to the OBI log, the most likely position of the inflow indicated by the Temperature log around the depth of 80 m, is a thin fracture at 79.2 m. The color of the rock (which is not indicated by other methods) changes at 56.2 m (Pic. 2.) Below that level the rock has a darker tone. The difference in color may indicate a slight change either in the composition or the weathering character of the rock. The slower sonic velocity, measured in the upper interval, is basically explained with the large number of the fractures, but this slight lithological change may also be a factor.

Picture 2.: The different colors mean other rock composition
